Manhole Inspection Summary

Manhole # S39AA_022MH

Insp Date: **8/14/08 1:28 PM**

Location Address: **e madison st**

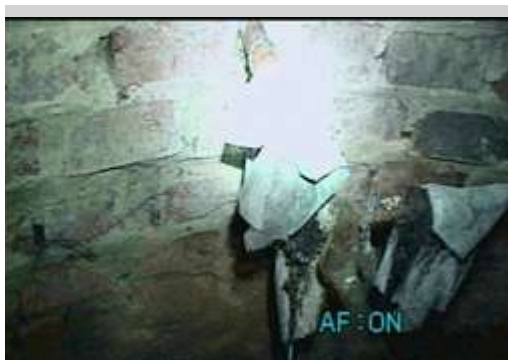
Defect 5

☒ **Evidence Of Surcharge** Depth: **3.7** (ft.) ☐ Active Surcharge Present

evidence of surcharge

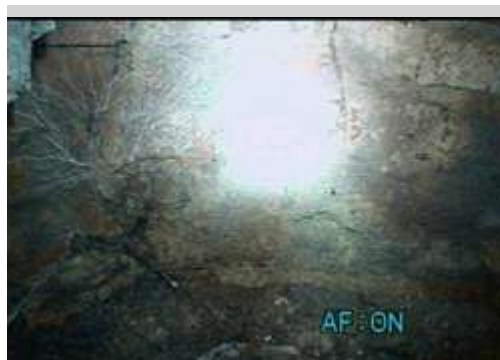
Defect 4

Condition: ☐ Sound ☐ Cracked ☒ **Root Intrusion** ☐ Loose Brick ☐ Deteriorated

roots in barrel

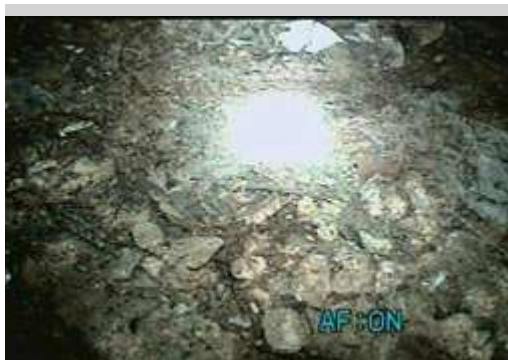
Defect 3

Condition: ☐ Sound ☐ Cracked ☐ Root Intrusion ☐ Deteriorated ☐ Leaks ☒ **Debris**

bench debris

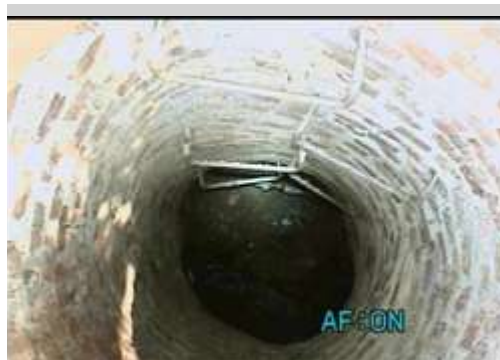
Defect 2

Count: **6** Missing: **0** ☒ **Corroded**

steps

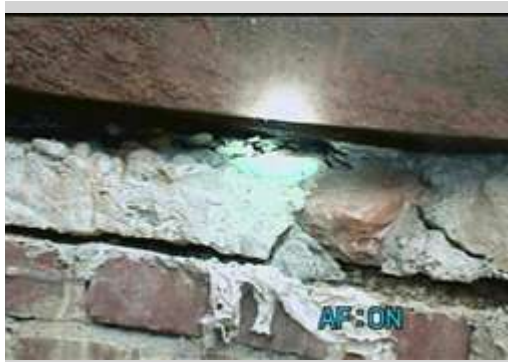
Defect 1

Condition: ☐ Sound ☒ **Cracked** ☐ Root Intrusion ☒ **Loose Brick** ☒ **Deteriorated**

chimney loose bricks, cracked,
deteriorated

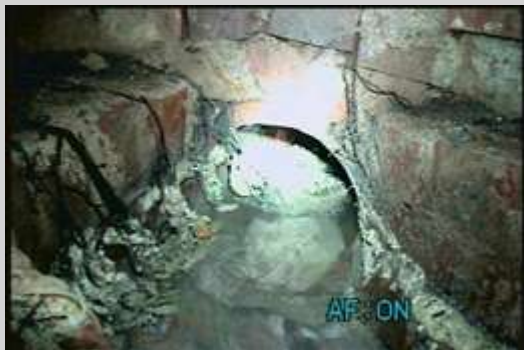
12 O'Clock Outflow

8 in. Circular Gravity Sewer
Pipe Out @ 12 O'Clock

Deposits: ☐ None ☐ Mud ☐ Sludge ☒ **Debris** ☐ Grease

Silt Depth: 0 (in.) Deposits Extent: **Medium**
